Periodic Dam Safety Inspection Report

Serenity Lake Dam

September 2001
Pub. No. 01-11-014

Douglas L. Johnson, P.E.
Dam Safety Office Supervisor

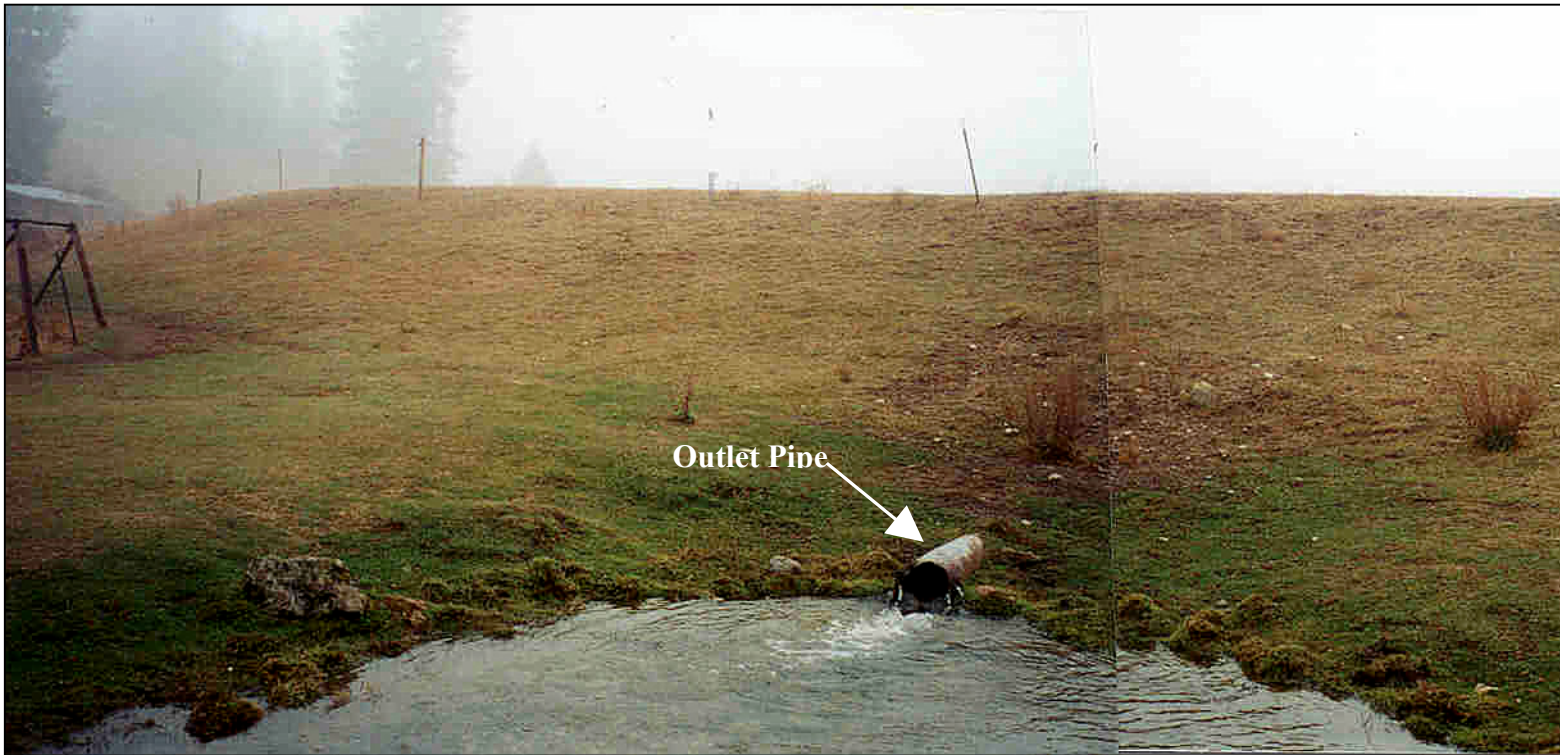
An examination of the downstream face of the dam revealed that there was no sign of cracking, sinkholes, settlement, or other instability. No seepage or wet areas were found on the downstream face or the foundation area. The only deficiency noted was animal burrows in numerous locations. These burrows likewise need to be filled in.

Photo 2: Downstream Face at Outlet Location

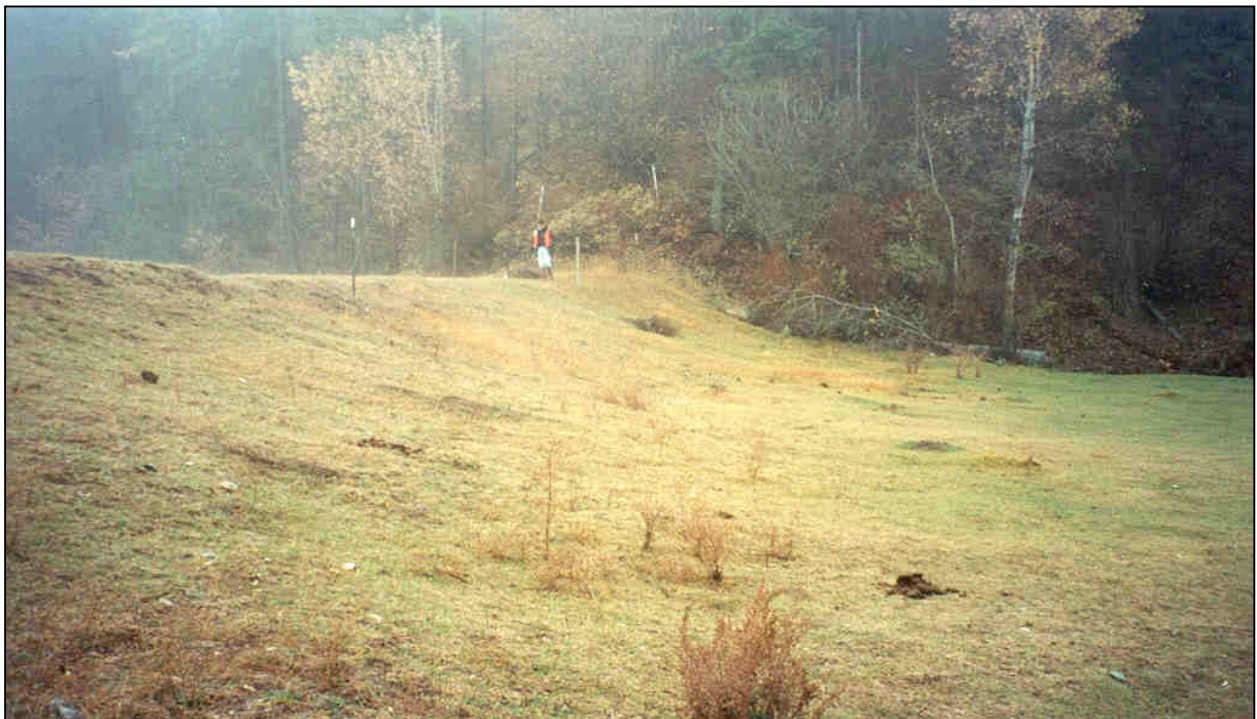
Photo 3: Downstream Face Looking South toward Spillway

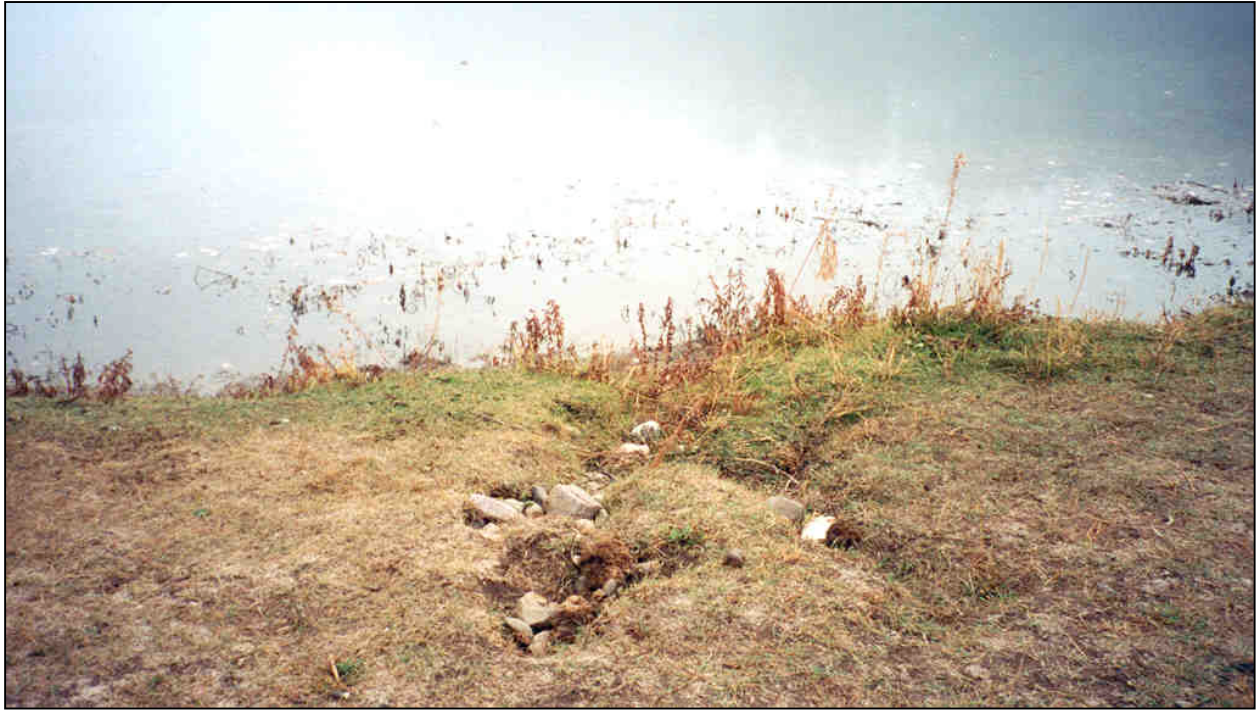
We next examined the dam crest, and discovered no cracks, sinkholes, erosion, or other signs of instability. Our survey of the dam crest showed that most of the dam crest was below the design elevation of 2143 feet. This has resulted in only 1.5 feet of freeboard instead of the 3.4 feet shown on the dam plans. Several animal burrows were noted crossing the crest, which could pass water if the pool rises to a few inches below the crest. We informed the Longs that these burrows needed to be filled in.

Photo 4: Collapsed Animal Burrows on Crest

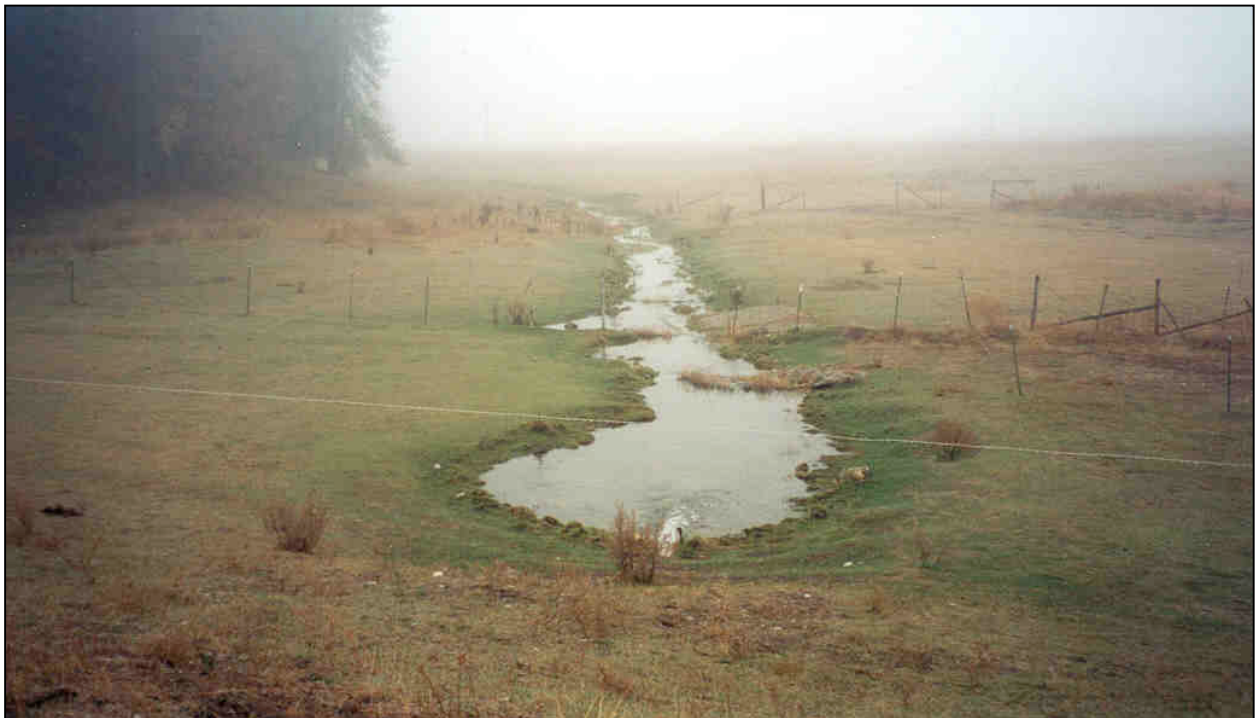
At the time of our inspection, the gate valve was partially open and the outlet was discharging about 0.5 cubic feet per second. Since the lake was full, we were only able to examine the downstream end of the 12-inch discharge pipe. The CMP was in fairly good condition, with only some minor rusting of the exposed portion noted. No seepage was noted from the embankment surrounding the pipe. The pipe discharges into a rock-lined pool at the downstream toe. No erosion damage or other problems were noted in this area.

Photo 5: Outlet Channel Downstream From Dam

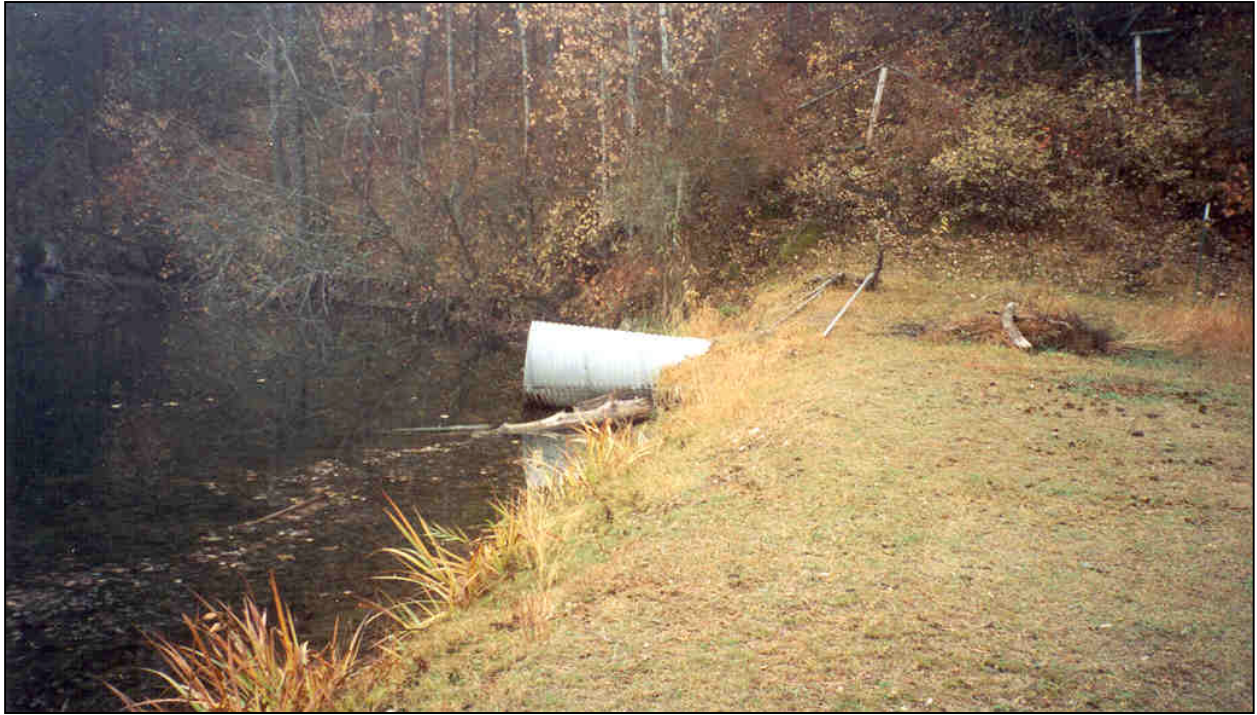
Our inspection of the emergency spillway showed the CMP to be in good condition, with no significant rust or corrosion noted. The logs and debris present during our last inspection had been cleared from the pipe and half-round flume. The flume was in somewhat worse condition than the pipe, with rust and corrosion noted on the invert, but it was still serviceable.

Photo 6: 36-inch CMP Spillway Conduit

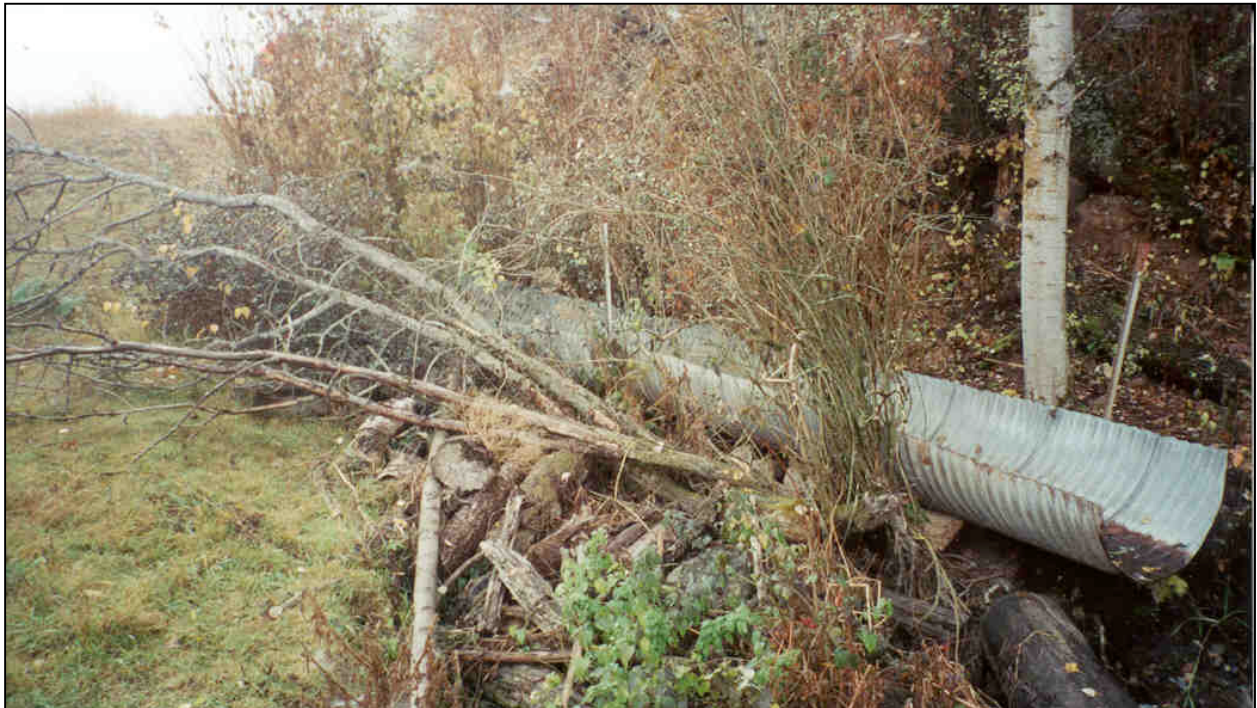
Photo 7: Half-round Flume Downstream from 36-inch CMP

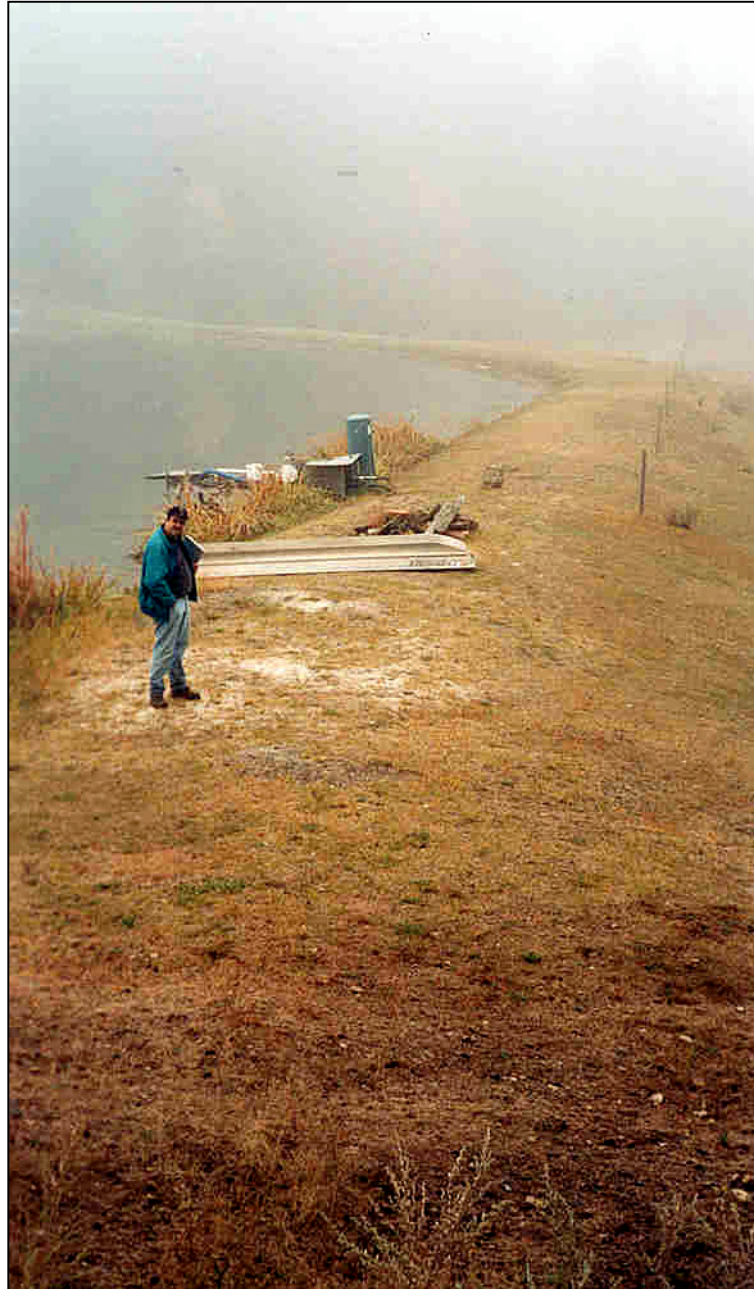
Photo 8: View of Dam from North Abutment. Person is Standing in Location of Proposed Emergency Overflow

Option 1: Raise Dam 0.7 feet and add 60 foot wide emergency spillway – This option would involve adding fill to the dam to restore the crest elevation to 2143.0 feet, and lowering a 60 foot wide section of the dam near the right abutment to act as an emergency spillway. The lowered section would have an elevation of 2141.0 feet, 0.5 feet above the invert of the existing spillway pipe. Ideally, this area would be in native soil and would require only minor erosion protection. This option would allow the lake level to remain at its current elevation. Figure 7 provides a conceptual drawing of this repair scheme. With these modifications, the dam can handle the IDF with 0.3 feet of freeboard below the crest elevation. The advantage of this scheme is that it would be relatively easy and inexpensive to construct. The disadvantage is that the lake would continue impounding more water than allowed under the reservoir permit and water right certificate, and the owners would have to apply for a water rights change from the Dept. of Ecology.
